**Item nr. 38920****Tool set for repairing of partialy broken stud M8 Fiat 2,3-3,0 SOFIM**

**Tool Set 38920 contains instruction manual + detailing photo documents.**

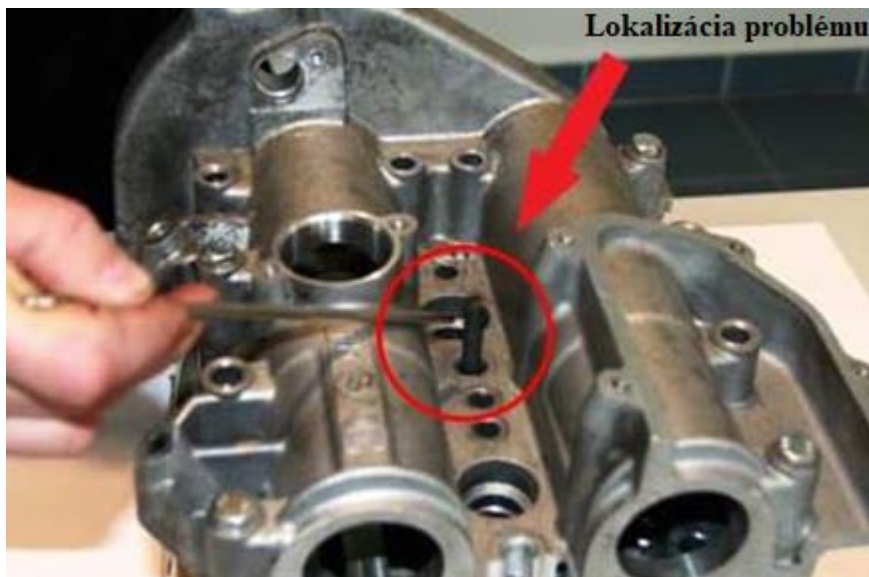
**Picture 3.** Cylinder head cross section Fiat Ducato HPi 3.0l

Diesel injectors of the engines mentioned above are fixed by bolt M8. The bolts of all injectors are situated in the camshaft cover recess, which is on the right end in the cover camshafts with drainage groove. Drainage groove serves the water removing which has flowed through a leak between the windshield and the hood. This technically imperfect solution to drain water causes water retention around the injectors and injector bolts which penetrates and settles between the steel bolt and the head of the cast, where bolt formed solid precipitate in the height of 22 mm. It cannot be chemically removed; it can be removed by manually linkages breaking.

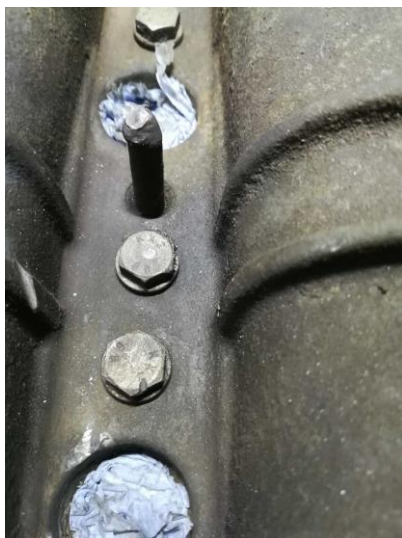
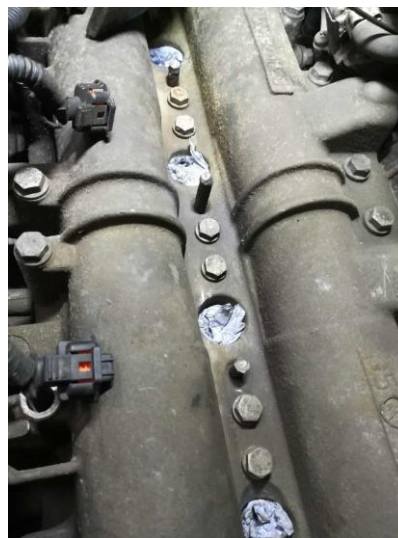
**Picture 9:** Cases, when cannot use tool kit nr. 38920

1. If the stud is short - cut too low under the head
  2. If residual chips of welded electrode remains on the bolt - there is not possible to cut the thread
  3. If the broken stud is too bent (bent stud shank) due to the use of excessive force
- However, the use of this tool kit is only possible if the protrude stud measures at least 20 mm so that the injector holder can be re-positioned in its place, and also allow to screw the hexagon nut onto the protruding portion of the broken stud.

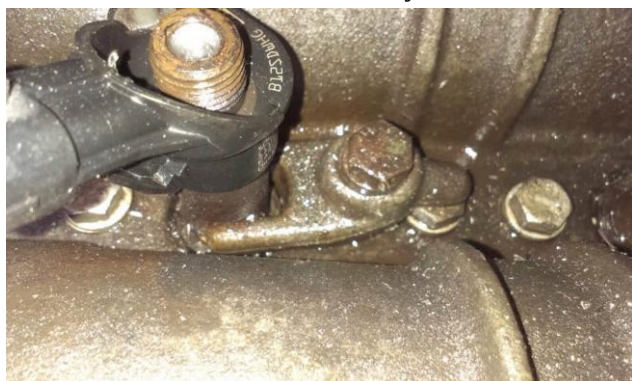
**Picture 10:** problem localization: installed injector, holding by injector holder and fixing bolt.

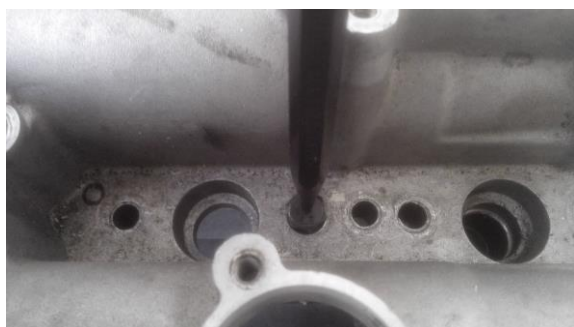
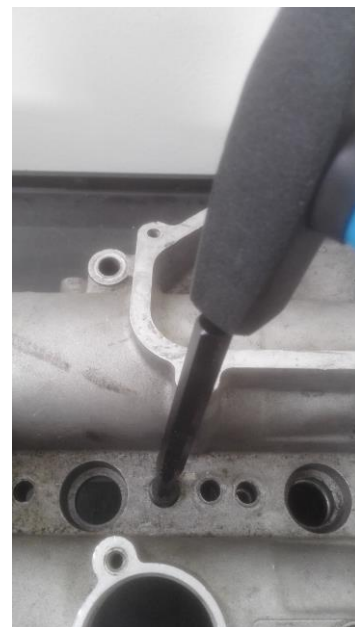
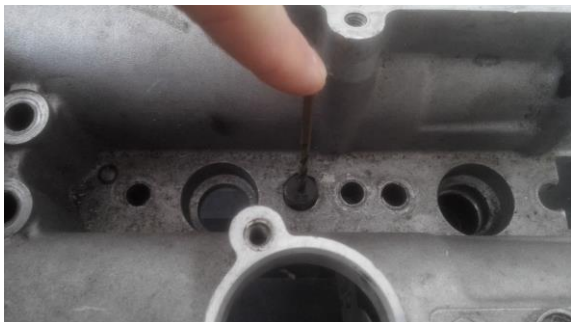
**Picture 11. Instruction for drilling** of hexagon head of holder 's stud of injector – using of center punch and drill 3mm Fiat Ducato HPi 3.0l

If you feel roll over of the ratchet during the releasing of injector holder stud and you cannot release the stud on first time, no additional force is required. Just use a 3mm center punch, to mark the center of the screw head and then use a 3mm cobalt drill to drill the head of stup in depth of 1cm. Then, use firstly 9mm cobalt drill then 11 mm drill and drill out complete head and the remaining part of the screw is now flat - ideal for cutting the required number of threads and finishing the replacement nut

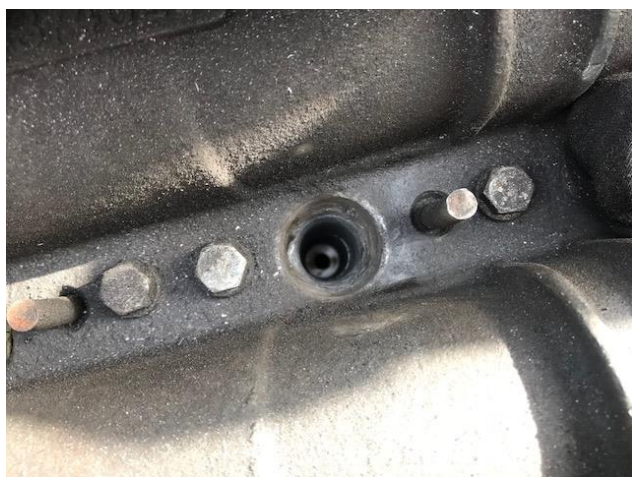
**Picture 12:** removed injectors, detail of broken stud without other changes

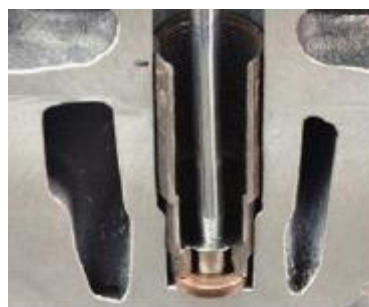
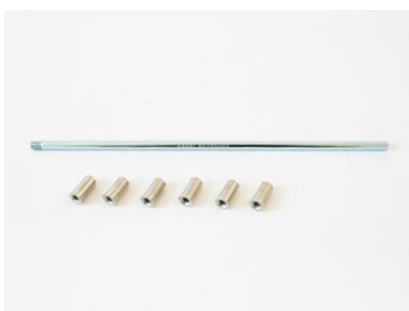
**Picture 13:** sealing plugs for blind of injector nozzle chamber order item nr. 5055

Then, we dismantle the injector as well as the injector holder. The injector must be removed, ensuring better access to the bolt. If the injector is already removed, it is recommended that the injector nozzle chambers will be blind with a sealing plugs - order number 5055 (sealing plugs for injectors Ø10mm, shank Ø7mm, plus insertion tool - not included in the set). There is recommended also remaining holes, hoses, pipes seal by clothes.

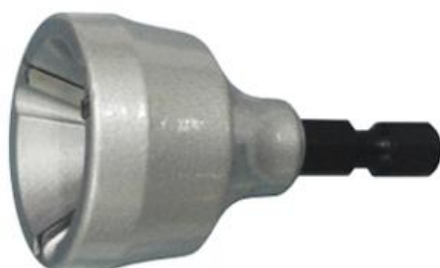
**Picture 14:** broken stud of injector holder M8 using by debburing tool item nr. 39375

The leading edge of the broken screw is need to deburr around the top using by deburring tool /item nr. 39375 by max. revolutions 400 rpm in a clockwise direction for 3-5 seconds.

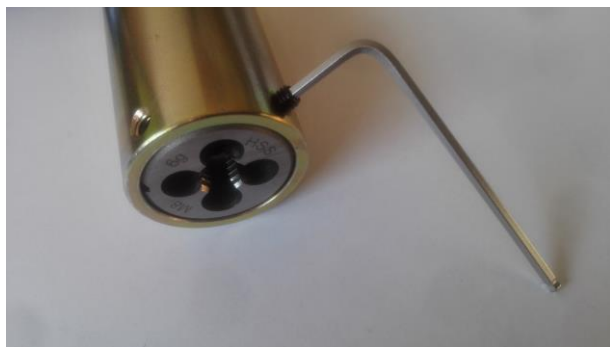
**Picture 16: installing of threaded die into the die holder using by 2mm allen key**

Insert the threaded die into the die holder and fix its position with a 2 mm allen key (allen key 2mm is also part of this set)

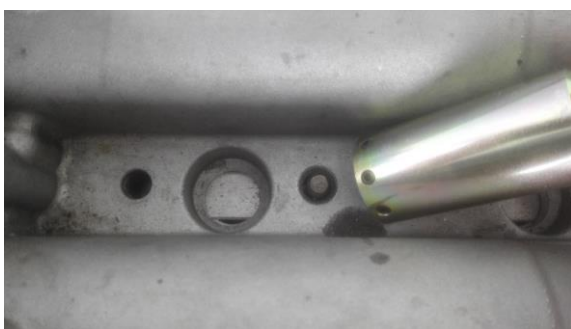
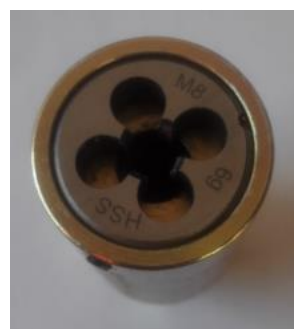
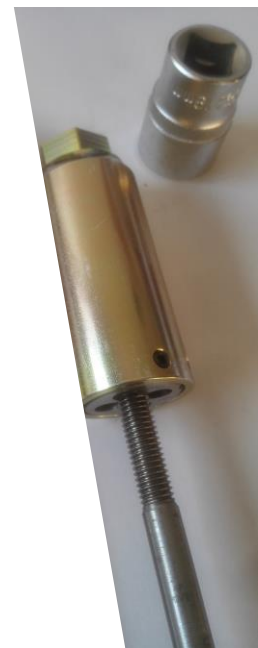
**Picture 17: Thread cutting made by ratchet with 19mm socket**

Tap the thread M8x1,25 with his depth of least 2/3. Make cutting of thread by threaded die item no. 3 inserted into the extension adapter item no. 4 and using a ratchet with 19mm socket.

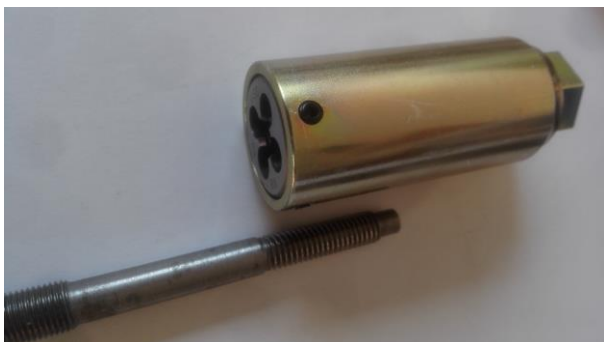
**Picture 18:** Cutting of sufficient thread numbers for protruding part broken stud M8.

The threaded die holder has a continuous hole under the threaded die M8x1,25 which allow the cutting of sufficient threads number. Then it will be screwed onto protruding part of broken stud. This protruding part of stud comfortably fits to milled hole in the threaded die holder. This will ensure that a sufficient number of threads are cut in order to firmly screw the hexagon nut to replacement nut repair of broken stud for injector holder.

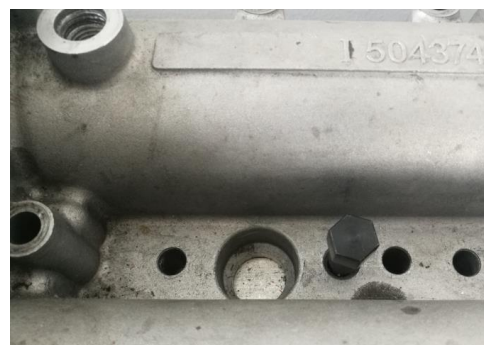
**Picture 20:** Mounting of a hexagonal nut on the injector older stud.

After cutting the thread on protrude stud, screw the spare hexagon nut no. 6 through the modified hole in the injector holder. Tight the nut with correct torque specified by the vehicle manufacturer. Screw the nut so that it catches a broken stud in a 15 mm overhang. The screw will be tightened

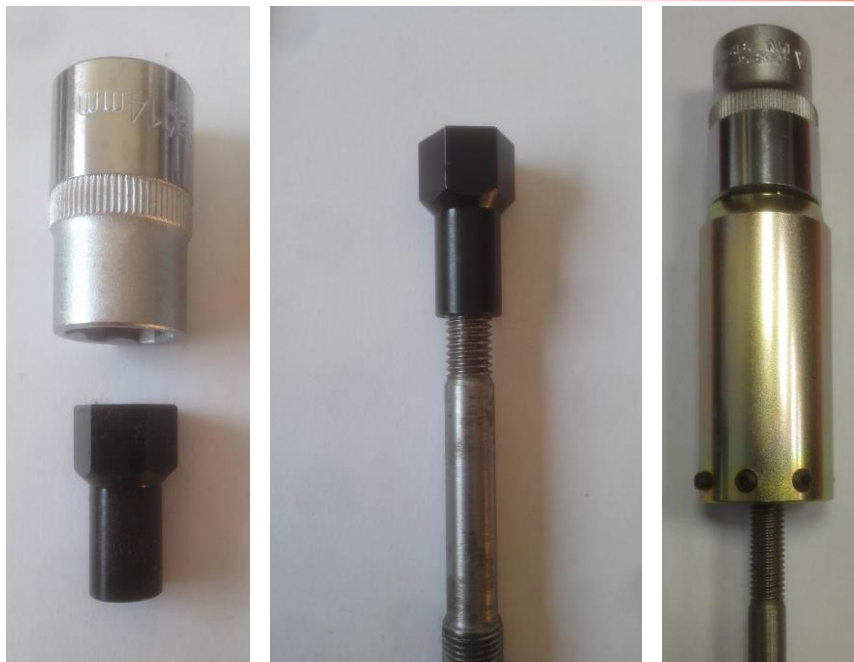
**Picture 21:** Spare replacement item nr: 39296 – 14mm hexagon nut with inner thread M8x1,25, body size 11mm.
